**REPORT FOR CODE & ACCESSIBILITY COMPLIANCE**  
**UUSS SITE & BUILDING ASSESSMENT STUDY**

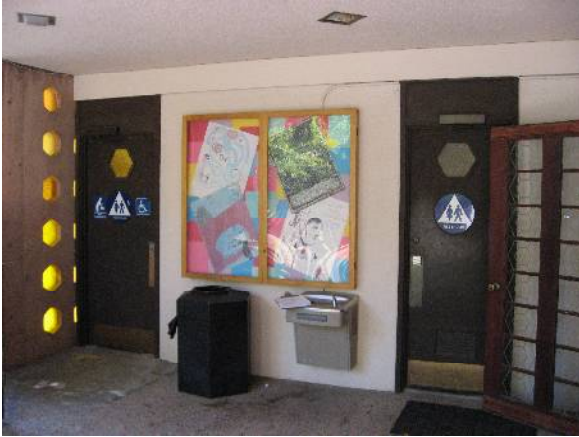
1. The non-accessible unisex Restroom Number 2 at the Classroom Wing should be clearly labeled as non-accessible for persons with mobility impairments. The unisex sign is not specifically noted in the code as denoting accessibility, but it is contained in Chapter 11B of the CBC, the chapter related to accessibility for public accommodations. Most people on seeing the circle with a triangle superimposed will assume the rest room to be accessible. This toilet room is not accessible for persons with mobility impairments and the signage could lead someone to believe it is at least partially accessible, when it is deficient in several significant ways. The primary deficiency is that is that the room does not have grab bars at the water closet so there is no way for a mobility-impaired person to use the facilities. Also the piping on the lavatory is not insulated so that if there is hot water available in this room a person with limited sensation in their lower limbs could burn themselves by contacting the hot drain line if hot water was in use at the lavatory. The entry door to this rest room is also too narrow to comply with current accessibility requirements. This rest room could be used by a visually impaired person who does not have mobility impairments, but not by a visually impaired person who is in a wheelchair. Note that the accessible unisex toilet Classroom Rest Room #1 has an ISA sign. The simplest fix for this now would be to remove the circle

and triangle signs from this door and label the restroom as a “Non-accessible Unisex Toilet” with accessible signage with raised letters and Braille type.

8. Retrofit the aging and possible poorly functioning panic hardware at the main Social Hall.
9. Retrofit the non-accessible unisex toilet room Rest Room 2 at the Classroom Building with grab bars and insulated piping, remove floor mounted urinal to increase maneuvering room in this room and re-sign accordingly once the work is completed.

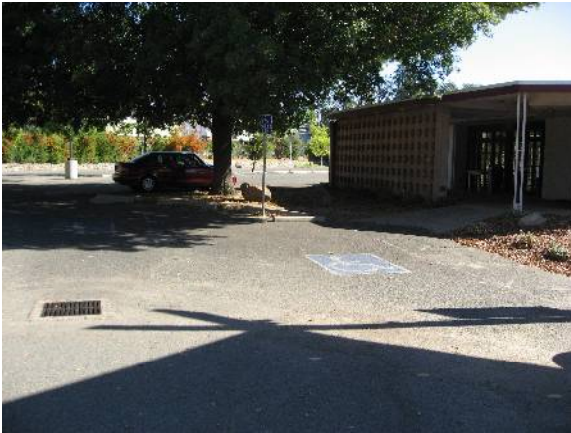
1. The accessible parking stall striping is faded and not compliant with current standards.

1. Repair step in path of travel near accessible parking for the Classroom Building
2. Restripe accessible parking stalls and repave as necessary to assure proper slopes at path of travel.
3. Provide code-compliant signage at parking lot entry and at accessible parking stalls.
4. Provide signage from parking area to accessible entry at the foyer.
5. Provide an accessible entry to the F.A.H.S. room with signage from the parking area
6. Provide accessible signage at rooms with permanent identification or permanently assigned uses such as; rest rooms, the minister's office and the main office.
7. Provide sill step mitigation and ISA at any doors identified as being desirable for disabled access, similar to provisions made at the existing accessible door to the Foyer.

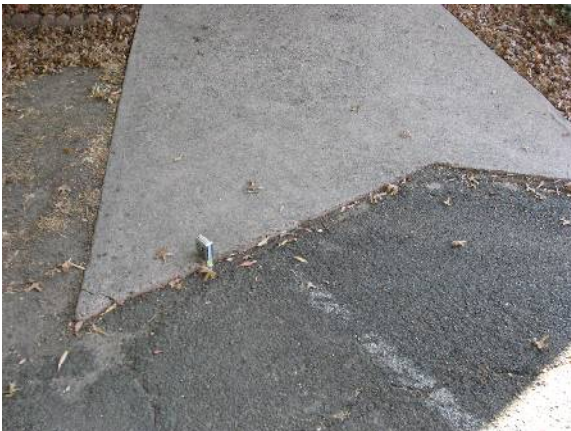
2. There is a 1", non accessible, step at the ramp leading to the Classroom Building from the accessible parking spaces near that building.

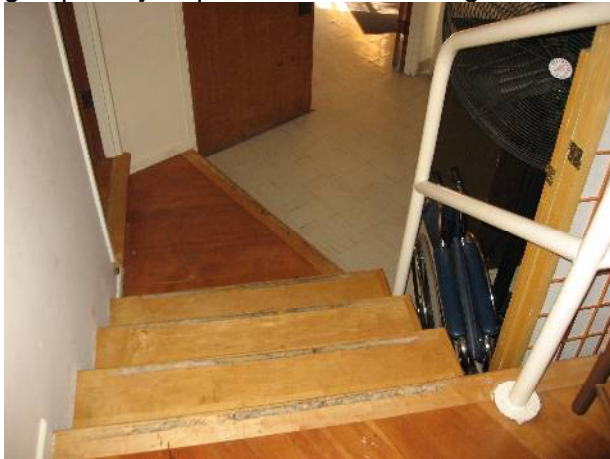
Stair railings are not compliant with current accessibility or egress standards. There are no extensions of the railings at the top and bottom as is required for access for visually impaired persons. The handrails at the rear of the stage are too large in diameter to meet current graspability requirements for both egress standards and accessibility.

13. Consider retrofitting the stair railings in the stage area of the Social Hall to be code compliant with egress and access requirements.
14. Consider sprinklering the facility even if no other alterations or additional buildings are contemplated. See the rationale for installing sprinklers in the Tier 3 discussion below.

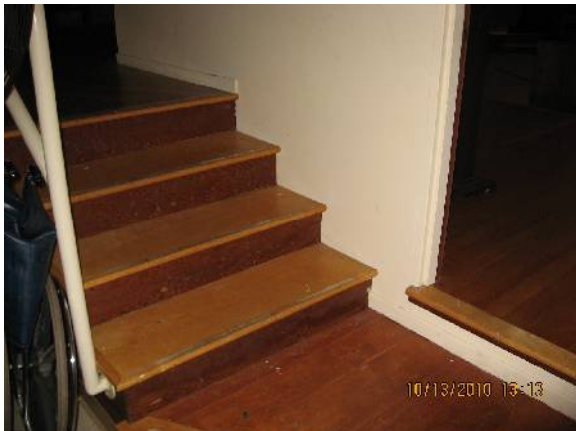
There is a step at a door into the stage area which does not have a landing associated with it. The stair risers at the steps around the stage in the Main Building are too high to be compliant with current standards of 7" maximum rise.

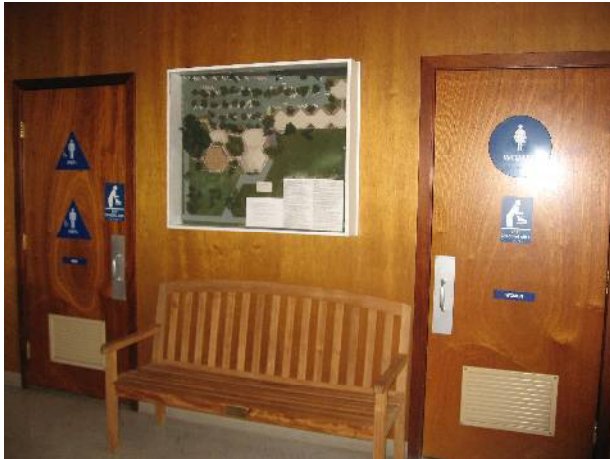
Men's and Women's Toilets Number 2 at the main building have been retrofitted to make them more accessible. They are both deficient in minor ways regarding compliance with current accessibility requirements. While some of the noted deficiencies may render the rooms only

partially accessible none of the deficiencies rise to the level of being hazardous to users of the toilet rooms.

1. The rest room should have a sign next to the strike side with raised and Braille lettering.
2. The lowered urinal is 18" to the rim. The proper accessible dimension is 17" maximum to the rim.

1. The rest room should have a sign next to the strike side with raised and Braille lettering.
2. There does not appear to be enough clearance outside the toilet stall to inscribe a 5' diameter turning circle in the toilet room outside of the toilet stall. There is probably sufficient maneuvering room for practical accessibility.

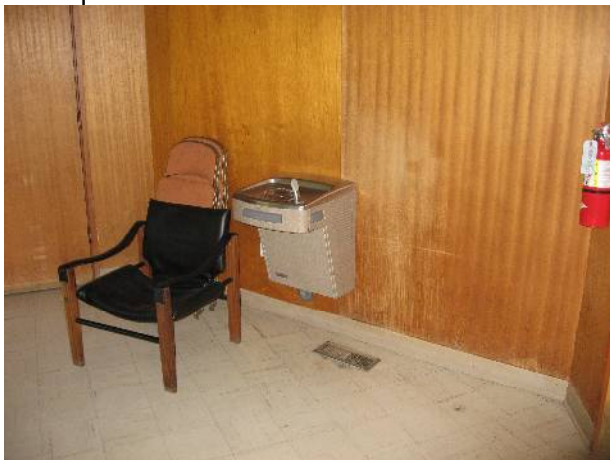
The drinking fountains in the lobby outside the toilet rooms do not have hi-lo facilities as would be required under current access standards.

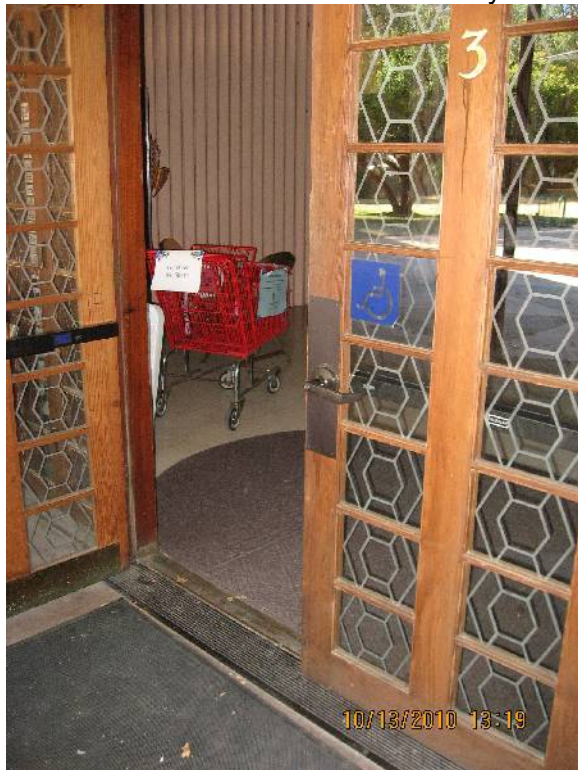
Door 3 at the Main Building has an altered threshold to be accessible and has an International Symbol of Accessibility (ISA) on the door. The door closer is above the required maximum of 5 pounds of operating pressure, but could easily be adjusted to meet that standard. There is not adequate signage from the public approach to the building from the parking lot to direct persons with disabilities to the accessible entry door.

The door opening force should be set at 5 pounds maximum for doors which are to be considered accessible. This is often a maintenance issue for exterior doors which may be blown open by high winds. I recommend that the only exterior door to be set with this opening force be the door identified with the International Symbol of Accessibility at the east side of the Main Building Foyer. See Tier 2 options for a discussion of alternative ways to address door opening pressures.

10. Consider providing power operators at accessible doors. This would require new power provisions to the door operators, but would allow the closers to be set with pressures high enough to keep doors closed in windy conditions.

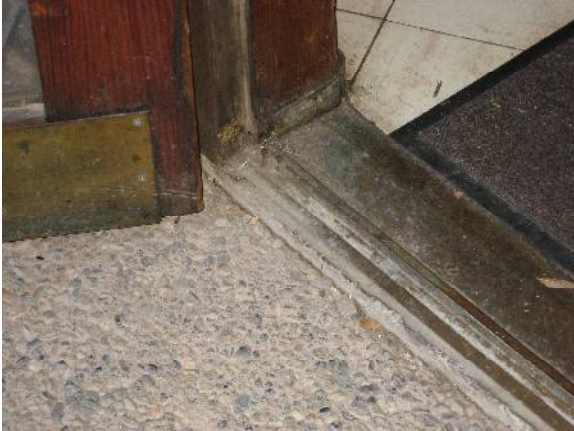
The other doors into the Main Building have old panic hardware, which appeared to be operational. The sills are too high to be considered accessible, except at the Foyer Door noted above which has been remediated with a sill plate attachment.
